# Manhole Inspection Summary

Manhole # S31E\_\_005MH

Insp Date: **8/5/08 11:26 AM**

**Location** Address: **rear 308 e fayette st**

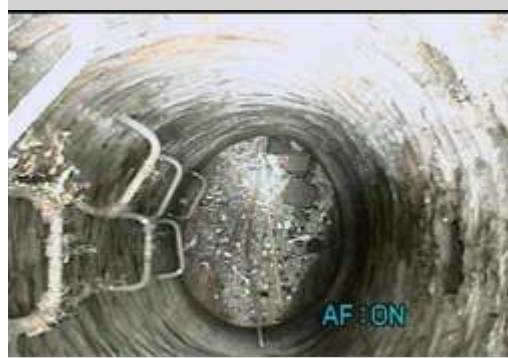
Top View

Condition: ☐ Sound ☒ **Cracked** ☐ Root Intrusion ☒ **Loose Brick** ☒ **Deteriorated**

chimney cond deteriorated with cracked, loose bricks
